Convention Paper 9884

Presented at the 143rd Convention
2017 October 18–21, New York, NY, USA

Evaluation of the acoustics of the Roman theatre in Benevento for discrete listening points

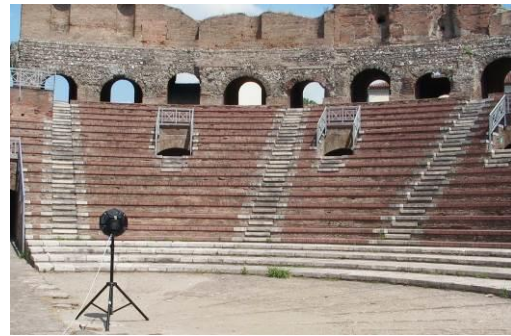
Figure 5 – Omnidirectional sound source in the orchestra during the acoustic measurements.

The acoustic measurements provided the acoustic features of the theatre, when either the actors are on stage or the musicians are in the orchestra. In order to obtain this information, a spherical sound source was first placed on the stage and then in the orchestra. The sound is detected through a microphone set in the cavea staircases at constant space in three radial directions. The sound emitted by the sound source interacts with the surfaces of the theatre and is then detected by the microphone set in the cavea. The sound detected by the microphone is the composition of the direct component, that means the one let out by the source and that directly reaches the microphone, and the one of the reflected components, that means the components of the sound that are reflected by the surfaces of the theatre before they reach the microphone. The sound source used to carry out the acoustic measurements consisted of an omnidirectional sound source, Peeker Sound JA12 (Peeker Sound Corporation, Reggio Emilia, Italy) a power amplifier KT 150. MLS signals of order 16 with a length of 5 seconds were generated by a 01 dB Symphonie system. The impulse responses were detected by a microphone type GRAS 40 AR ½”. The sound source height from the floor was 1.60 m from the floor. Figure 5 shows the omnidirectional sound source in the orchestra during the acoustic measurements. The microphones were placed on the steps of the cavea,

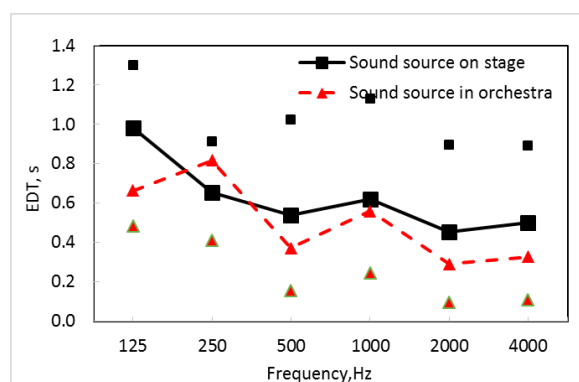
Figure 8 - Average measured values of EDT.

Referred to the sound source on the stage and the sound source in the orchestra, Figure 7 shows the average measured values of T_{30} ; Figure 8 shows the average measured values of EDT; Figure 9 shows the average measured values of C_{80} ; Figure 10 shows the average measured values of D_{50} .

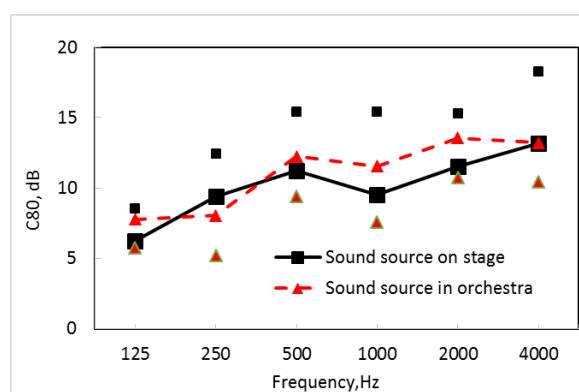
Figure 9 - Average measured values of C_{80} .

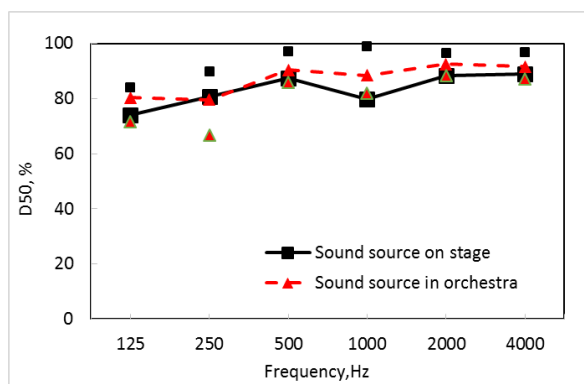
Figure 10 - Average measured values of D_{50} .

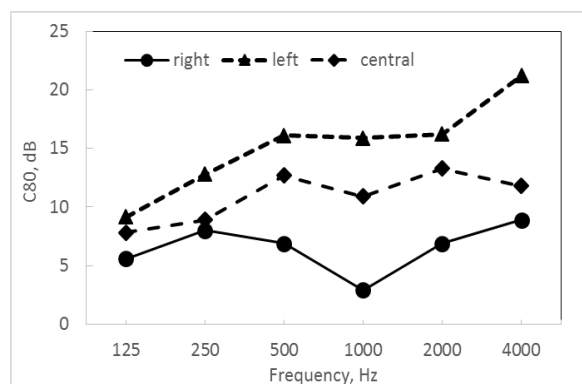
Figures 13 - C_{80} values for the eighth row.

For the position of the sound source on the stage, Figures 11, 12, 13 and 14 show respectively the C_{80} values measured for the first, fourth, eighth and twelfth rows. The C_{80} values are reported for each row and for three different directions. The measured values are based on 125 to 4 kHz octave bands, and are reported for the left, central and right rows.

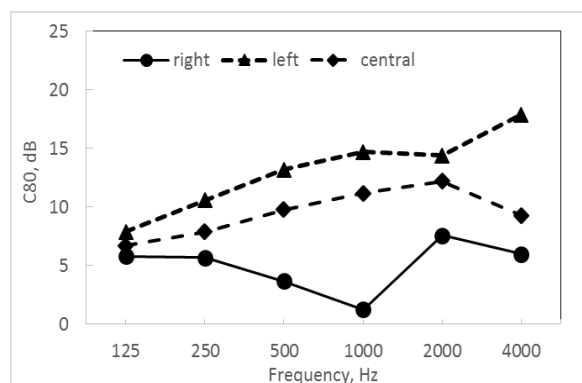
Figures 14 - C_{80} values for the twelfth row.

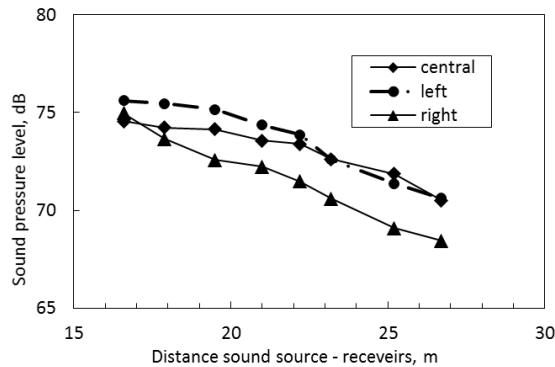
Figure 19 – Trend of sound pressure level with the distance when the sound source is placed on the stage.

The cavea in the right area, compared to the stage, has not been rebuilt, and on the right upper part of the cavea is occupied by the church built in the Middle Ages, “*Santa Maria della Verità*”. All these non-symmetrical surfaces help to obtain different values for each radial measurement direction. The D_{50} values are near to the unit value (good value for speech performances), while the C_{80} varies from 0 dB to 25 dB. Only the first row of the cavea area presents optimal listening conditions for music. The average values of $STI=0.81$ when sound source was on the pit and $STI=0.84$ when sound source was in the orchestra. This values confirm an high value for the direct sound components. The theatre nowadays is good for speech understanding, in fact the speech reception is very good throughout the huge audience area. Figure 19 shows the change of the sound pressure level (L_p) with the distance when the sound source is placed on the stage. The change in the sound pressure level along the right direction is lower than the other directions. While the change in

the sound pressure level is greater along the left direction.

When the sound source is placed in the orchestra, Figure 20, there is an inversion of the values of the sound pressure level (L_p). The change of the sound pressure level as the distance increases along the right direction is greater than the left direction. Moreover, in Figures 19 and 20, it can be noted how the change in the sound pressure level as the distance increases does not decrease in the average area of the cavea as expected but increases. This behaviour is due to sound reflections on the steps. In

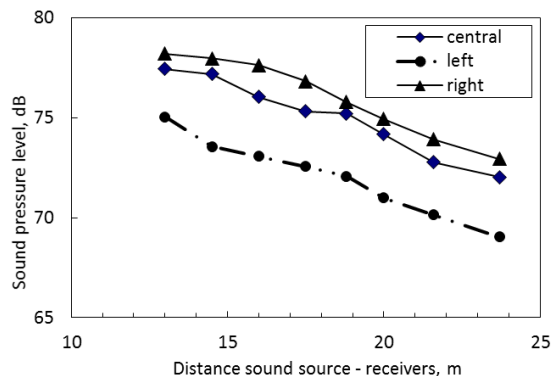
Figure 20 – Trend of sound pressure level with the distance when the sound source is placed in the orchestra.

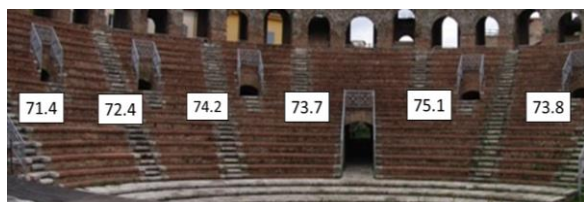
Figure 22. Sound pressure level (dBA) in the cavea, when sound source in the orchestra.

With the sound source on the orchestra, Figure 22 shows the value of sound pressure level (L_p) in dBA for six different microphone points in the cavea at the seventh step. The value of the sound pressure level (L_p) is higher on the right part of the cavea, while on the left part the sound pressure level (L_p) value is inferior.

The acoustic measurements confirm that the theatre is not symmetric, the levels on the right side of the cavea are greater than for the left. This is due to the contribution of the sound reflections of the exterior walls of the church built in the Middle Ages on the right side of the cavea.
