# TALK

SOUND

Bulletin No. 34

## VARIOUS ASPECTS OF "TAPE NOISE"

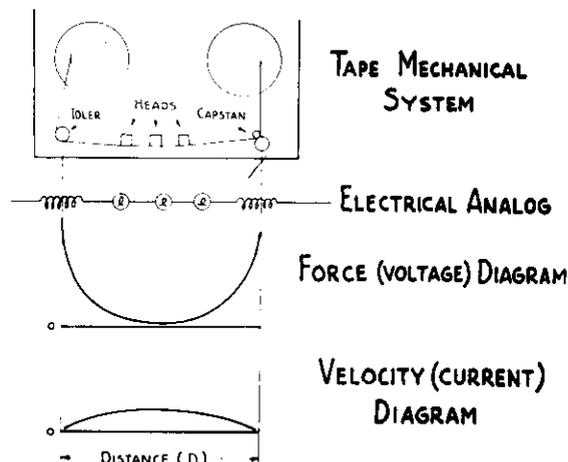
Figure 1. Diagram showing the mechanical drive parts of a tape recorder. Longitudinal tape vibrations are excited by friction with the heads and exhibit an amplitude pattern as shown.

The tape is usually driven past the recording heads by a mechanical drive system similar to that illustrated in Figure 1. The free span of

tape between the capstan drive and the idler roller represents a highly resonant mechanical body which is easily excited into longitudinal vibration by friction as it slides over the heads. The resultant fluctuations in tape motion cause frequency modulation of the recorded signal which may be audible as noise.

This type of noise is quite easy to demonstrate by recording a sine wave tone of about 3 to 5 KC and listening for the background noise. It can be verified that the origin of the noise is motion flutter by placing a small roller in contact with the tape near the point of contact with the recording or reproducing head. In most cases a sharp drop in background noise results, and the signal is noticeably clearer.

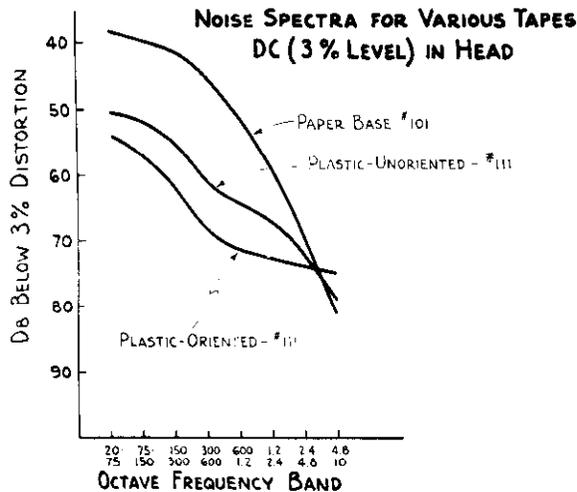
Figure 2. DC noise spectra for paper base tape and plastic base tapes with and without particle orientation. Tape speed 7.5 ips. NARTB playback equalization.

It is in the microstructure of the magnetic coatings that the greatest strides have been made in the reduction of noise in magnetic tapes. This is illustrated in the DC noise spectra of Figure 2.

These curves were made on a standard audio recorder at 7.5 ips speed using normal recording bias. A DC current corresponding in amplitude to the RMS value of a 3% distorted signal was also introduced in the head winding to simulate the effect of a recorded signal.

The resulting playback signal was passed through an amplifier equalized to the NARTB curve and measured on an octave band filter. The readings for the various octaves (indicated on the abscissa) were plotted as a "spectrum". The octave band filter method obviates many of the difficulties normally encountered in measuring tape noise with a sharply tuned wave analyzer.

Early tapes manufactured in this country employed a paper base which, owing to the porous and fibrous surface, were a rather poor support for a magnetic coating. The coarse microstructure of coatings on paper gives rise to the high modulation noise level noted in Figure 2.

came with the introduction of plastic film base. It can be seen that early acetate base tapes with unoriented coatings were some 10 db improved over the paper tape. It is interesting to note that noise in the highest frequency bands actually increased in going from paper to plastic base, presumably because of the improved head contact and playback resolution.

Since about 1950, particle orientation has been employed to reduce the modulation noise level and increase the sensitivity of magnetic tape. The decrease in modulation noise averages about 5 db for oriented tapes as shown in Figure 2.

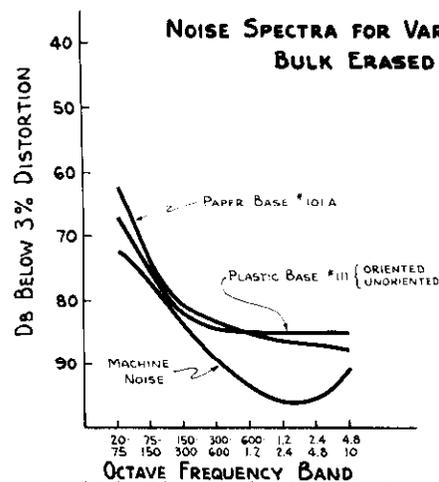
Figure 3. Bulk erased noise spectra for the same tapes as in Figure 2. The machine noise (tape motion stopped) is also shown.

The erased noise spectra of Figure 3 apply to the same three

tapes of Figure 2, and it will be seen that, although the paper base tape, the unoriented plastic base tape and the oriented plastic base tape all have widely different modulation noise spectra, the erased noise levels are remarkably similar. This strongly suggests that irregularities on a size scale larger than that of the particles do not influence the background noise. Incidentally, the identical type of oxide material was used in each of these examples.

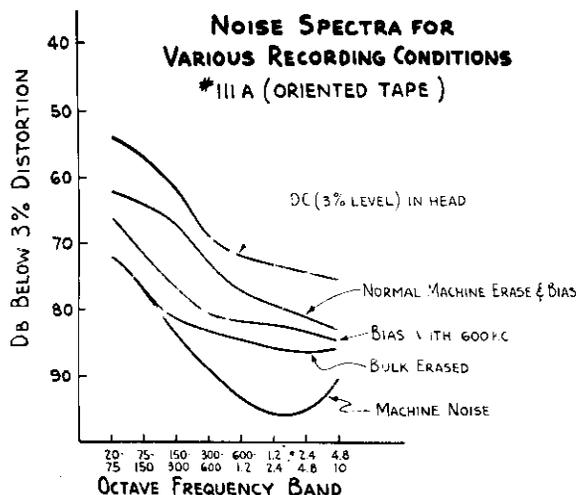
Figure 4. Noise spectra showing the effect of various erasure conditions.

The problem of adequately erasing tape and preserving the zero signal portions in a neutral state during recording are not easily solved. This is illustrated in the noise spectra of Figure 4. The same

standard "Scotch" Brand No. 111 tape with plastic base and oriented coating was used throughout, and the conditions of erasure of the tape varied to give the results plotted.

The tape was first bulk erased and played on the machine to determine the "lowest" background noise level. The tape was then erased and biased on a properly adjusted commercial recording machine (with no input signal and the gain turned back to zero) and the noise level was seen to rise about 10 db.

In order to verify the fact that the 100 KC bias was being recorded, an external bias source of 600 KC was also tried. This lowered the noise level by some 4 db, indicating that some improvement could be gained by going to a higher bias frequency. Some 60 cycle signal was recorded, however, in spite of precautions taken in the selection of a push-pull oscillator and amplifier for the 600 KC source.

The upper curve of Figure 4 shows the effect of a considerable amount of DC magnetization in the tape such as might be caused by a leaky coupling, condenser or a very bad bias wave form. It is interesting to note that the noise output of the tape may vary by as much as 20 db depending upon the conditions under which it is recorded. It is also apparent that extra precaution in setting up the recording equipment may be well rewarded in terms of consistently low noise level recordings.
